ARIZONA WELLS: MAINTAINING AND TROUBLESHOOTING WELLS

Janick F. Artiola, Ph.D.; Kristine Uhlman, RG; and Gary L. Hix, RG

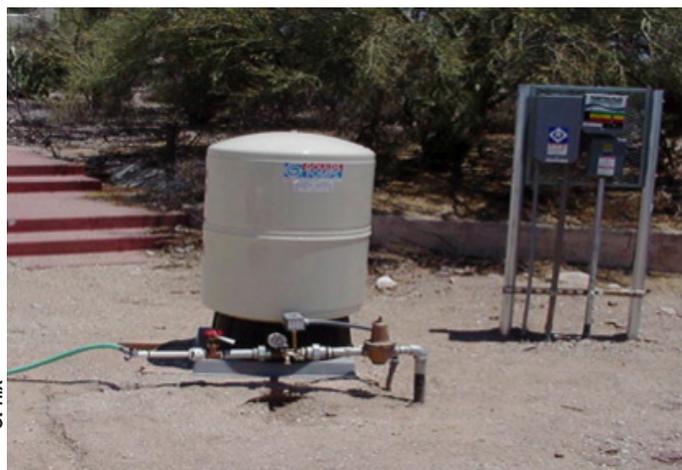
Figure 1. Typical Domestic Well System with Pressure Tank

If the sustained yield of the well is insufficient for the landowner's immediate needs, water storage tanks and secondary booster systems are constructed to provide higher flow rates. If the sustained yield of the well and pumping equipment is sufficient for the homeowner's needs a smaller water system can provide the needed water.

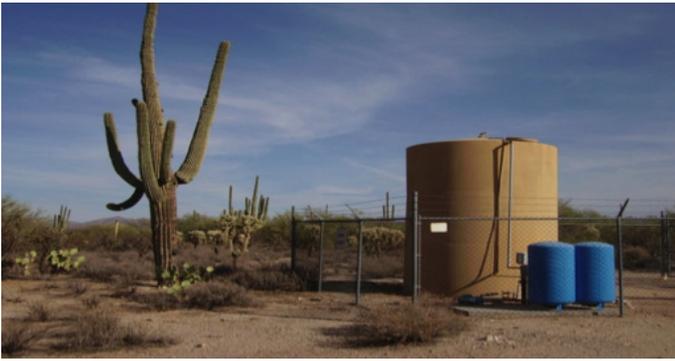
Figure 2. Typical Domestic Well System with Storage and Two Pressure Tanks, and Booster Pumps.

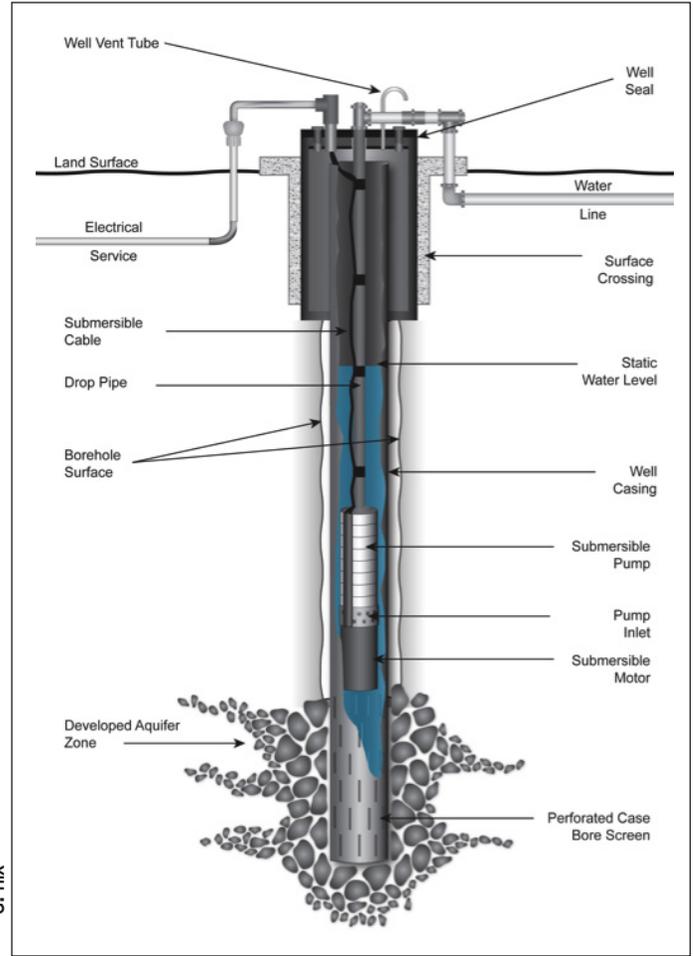
Figure 3. Well Cross-section with Components.

Domestic wells today are typically drilled with machinery that makes a borehole in the aquifer slightly larger than the well casing that is installed. The upper portion of the well casing is typically blank casing and the lower portion of the well casing is typically perforated or slotted (Fig. 3). The lower portion is called the screen section of the well, which allows for the movement of water into the well while reducing the transport of silt and sands into the well. If the slots in the screen are too small, aquifer sediment can clog the screen lowering the well yield. If the screen slots or perforations are too large, excessive amounts of silt and fine sand (grit) can enter the well, which can quickly wear out the pump moving parts, shortening its life.
